SUMMARY
1234 Main Street Fall Branch
Tennessee 37656
Buyer Name
12/10/2023 9:00AM

KC Bartley
Certified Master Inspector - TN Lic. #1244
Professional Home Inspections LLC
(423) 306-0508
kc@prohitn.com

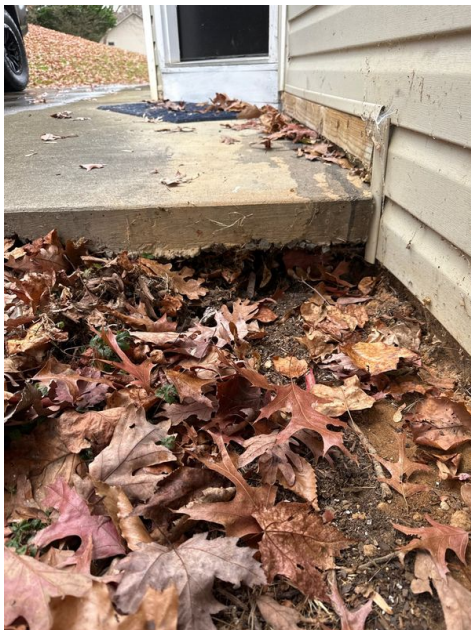
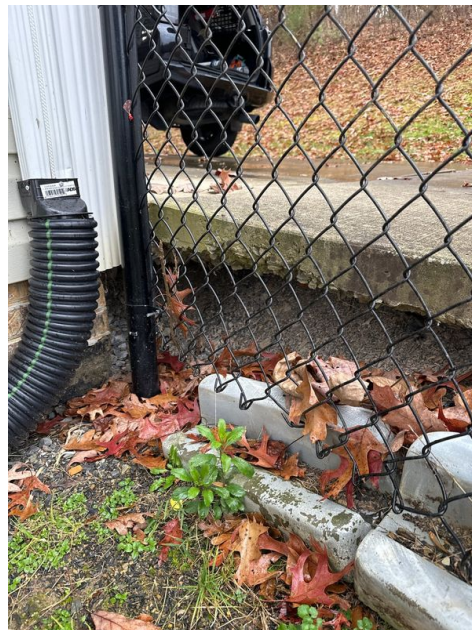
DRIVEWAY AT REAR OF STRUCTURE

3.1.1 Driveway and Walkway Condition **VOIDS/UNDERMINING PRESENT**

Void(s) or some degree of undermining was present under portions of the referenced concrete slab(s). This is typically from settlement/consolidation of the soil below the slab, but can also be due to erosion. Voids under concrete slabs can allow for cracking, displacement, or settlement of the concrete. Repairs to the void(s) as needed to support the slab(s) properly is recommended to be conducted by a concrete contractor.

Recommendation
Contact a qualified professional.

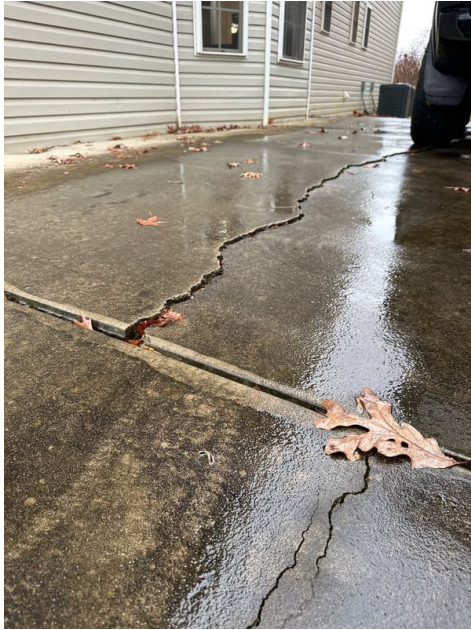
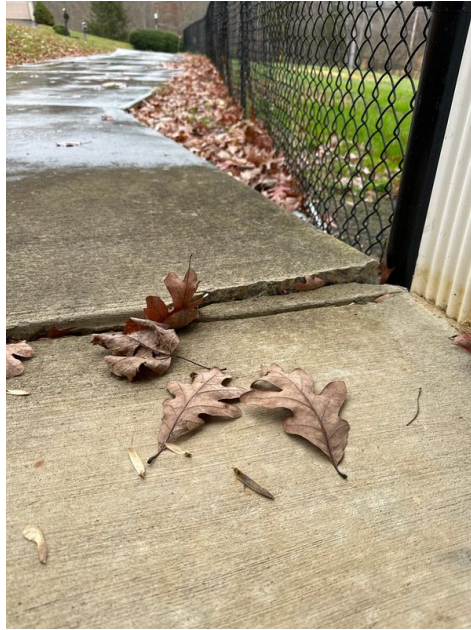
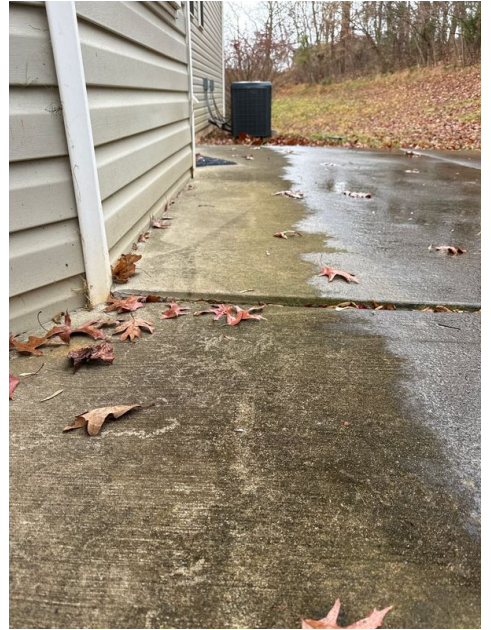
REAR OF STRUCTURE

TRIP HAZARD(S) PRESENT

SFTY - Cracking, heaving, settlement, movement, deterioration, and/or other deficiencies resulting in trip hazards were present on the referenced surface(s). Repairs are recommended to be conducted to these area(s) as needed for safety by a qualified contractor.

Contact a qualified professional.

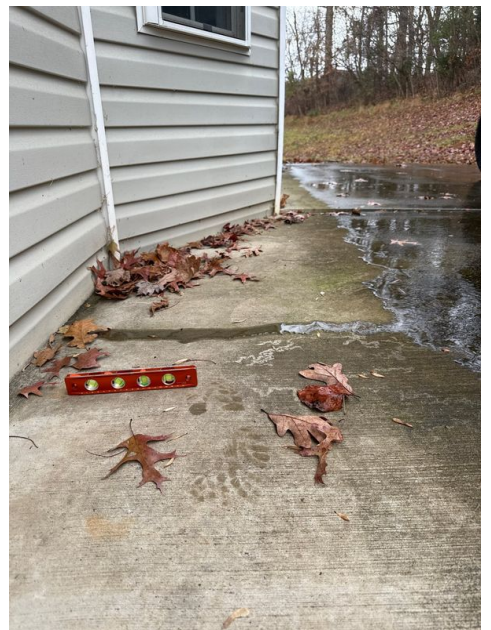
REAR OF STRUCTURE

DRIVEWAY - NOT SLOPED ADEQUATELY

The driveway was not properly pitched away from the structure. Driveways (considered hardscapes) should pitch away from the structure at 1/4 inch per foot (2% grade) to allow for the runoff of rainwater. Repairs are recommended to be conducted as needed by a qualified contractor to manage rainwater runoff in the area properly.

Contact a qualified concrete contractor.

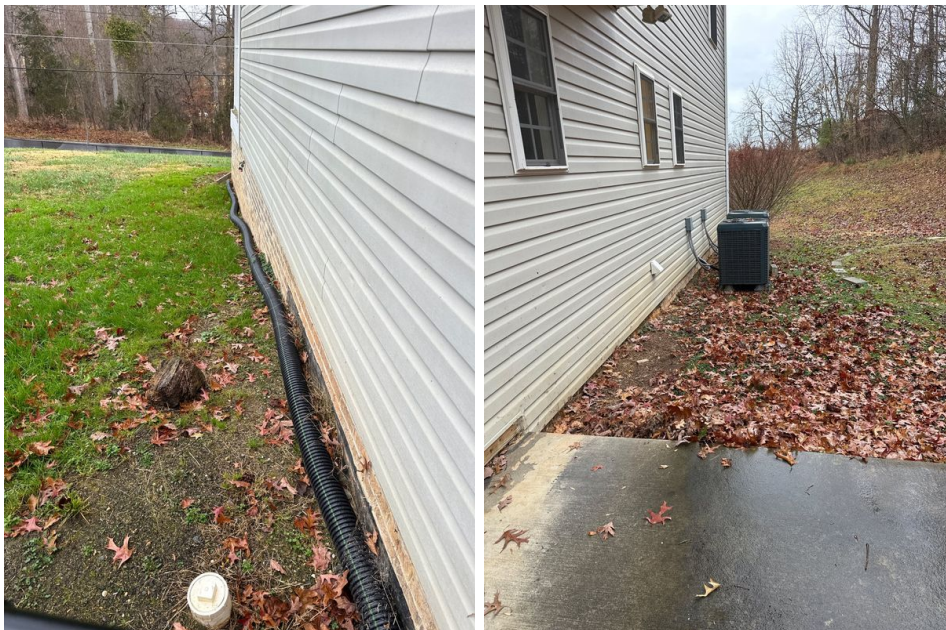
REAR OF STRUCTURE, RIGHT SIDE OF STRUCTURE

GRADING - NOT DESIGNED TO MANAGE RAINWATER

The current configuration of the grading will not allow rainwater to run away from the structure properly in the referenced area(s) or portions of the referenced area(s). Grading is either wrong or right, with no gray areas in between. The grading either slopes away from the structure (Right-Positive Grading), is flat (Wrong-Neutral Grade), or slopes towards the structure (Wrong-Negative Grade). Though no repercussions may be present at the time of inspection due to improper grading, moisture infiltration through foundation walls is always possible during heavy rainfall events.

Flat and negative grading allows the soil in these areas to become saturated. Once saturated, the porous, permeable masonry foundation walls can wick this water out of the soil via capillary action allowing the masonry to become saturated and either evaporate this moisture into areas below grade in the form of water vapor, creating high humidity, or allowing for moisture or water infiltration into areas below grade.

As mentioned in the "Grading/Drainage Information" comment above, the soil is recommended to slope away from the structure, with a 6-inch drop in elevation, in the first 10 feet away (5% grade). When the proper grade can not be achieved, a swale or drain should be installed to manage rainwater runoff. An evaluation of the grading around the home with repairs made as needed to allow for the proper runoff of rainwater is recommended to be conducted by a grading contractor, foundation contractor, or other qualified professionals.

Contact a qualified grading contractor.

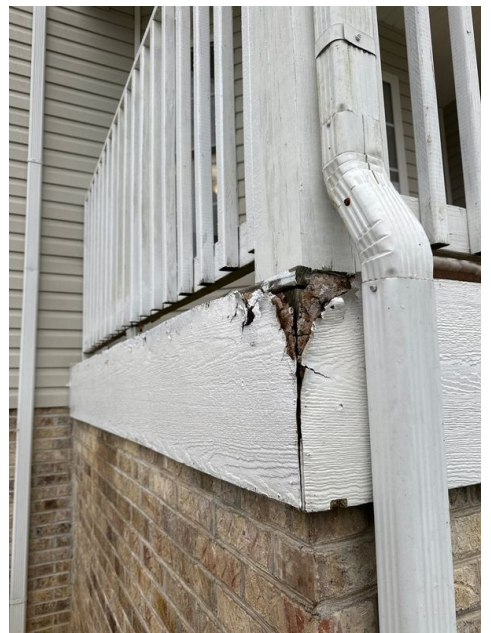
WOOD - WATER DAMAGE PRESENT

Some degree of water damage was present to portions of the wood framing or decking boards. An evaluation and repairs or replacement of any affected wood is recommended to be conducted by a deck contractor.

Contact a qualified deck contractor.

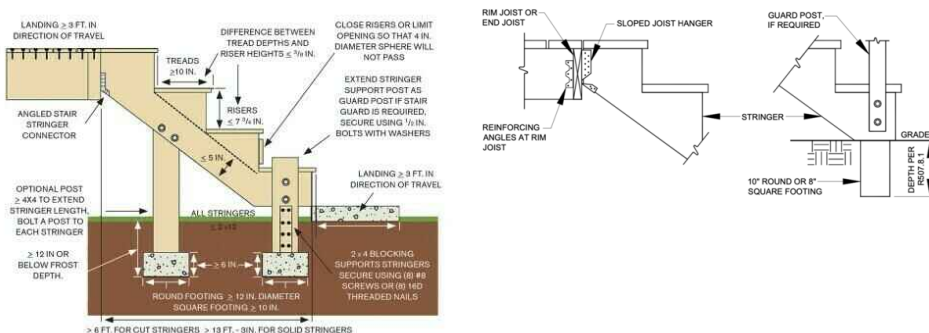
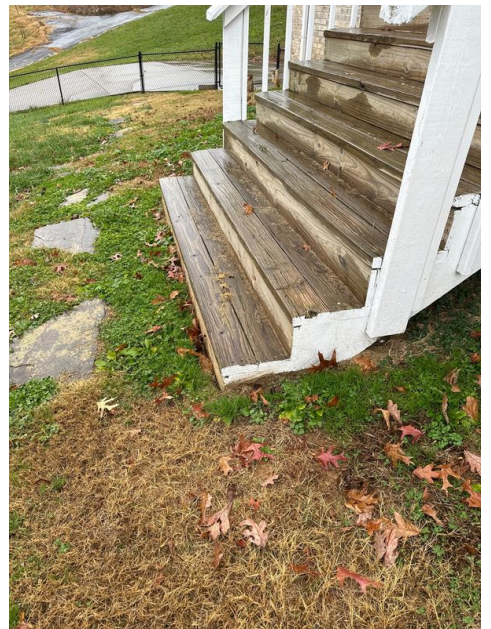
STRINGER - IMPROPER BEARING AT GRADE

Component(s) were missing at grade that allows for proper stringer end bearing. The base of the stringers should have a support post attachment that bears on a properly sized footing set at a depth defined by current standards. Repairs to properly support the base of the stringers is recommended to be performed by a qualified contractor.

Contact a qualified deck contractor.

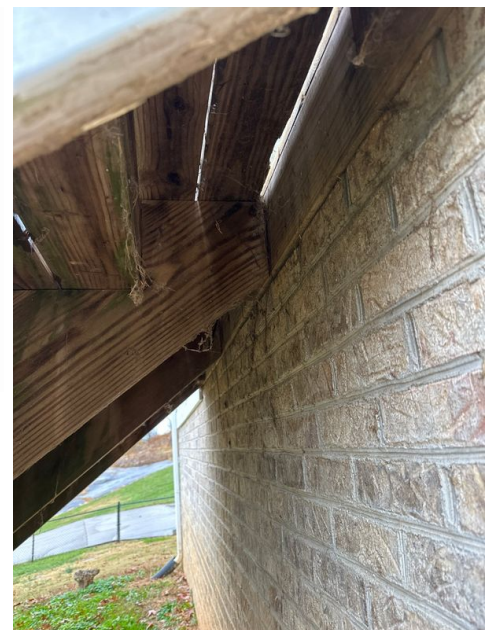
STRINGER(S) - MISSING HANGERS

Hangers were not used to secure the stringers to the deck framing. The installation of slopeable hangers is recommended to be performed by a qualified person to properly secure the stringers.

Contact a qualified deck contractor.

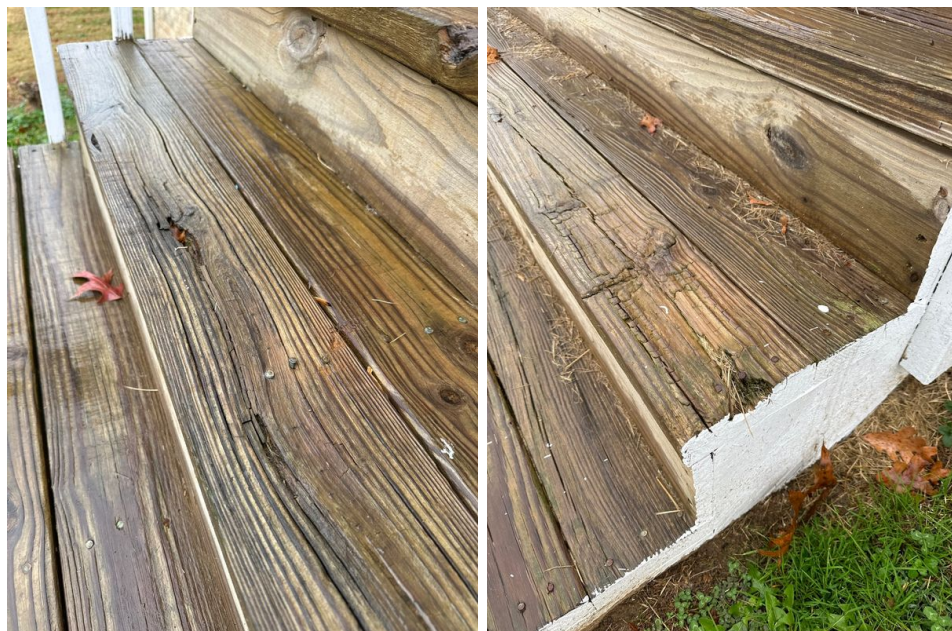
WOOD - WATER DAMAGE

Minor to moderate water damage was present on portions of the wood stair components. Repairs or replacement of any damage as needed is recommended to be performed by a qualified person.

Contact a qualified professional.

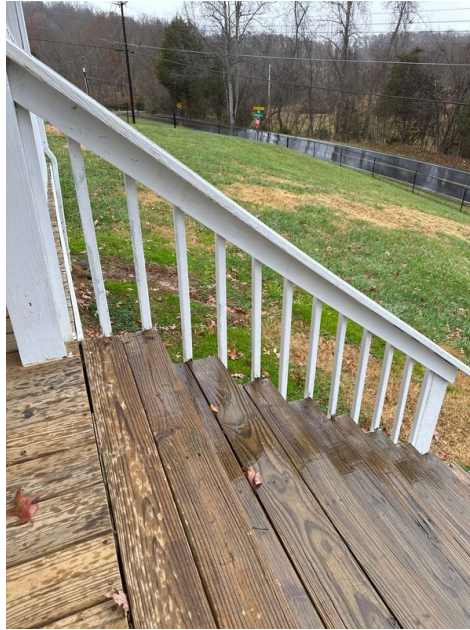
SFTY - The stair railing height was less than 34". Current safety standards require the height of stair railing to be between 34" - 38" for safety. Safety upgrades or modifications are recommended to be conducted here by a qualified contractor.

Contact a qualified professional.

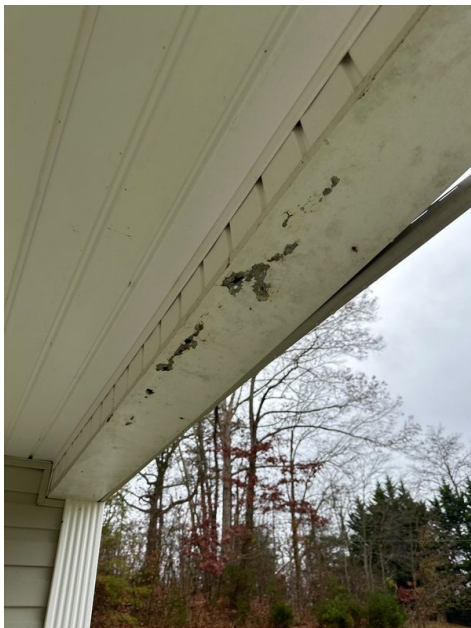
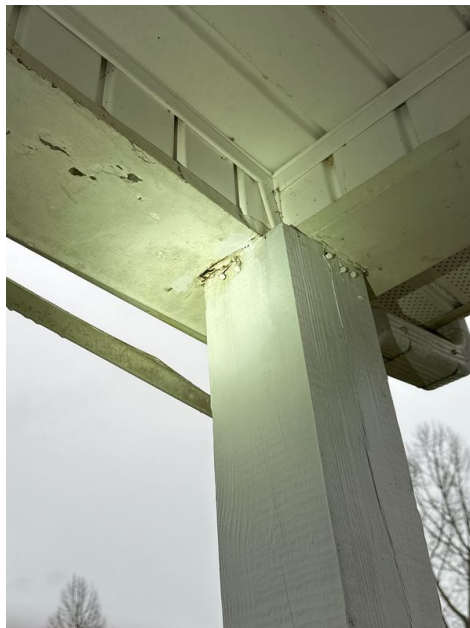
ROOF FRAMING - DAMAGE

The roof structure or related/adjacent components of the referenced appurtenance roof contained some degree of damage. Repairs to any damage present is recommended to be performed by a qualified contractor.

Contact a qualified professional.

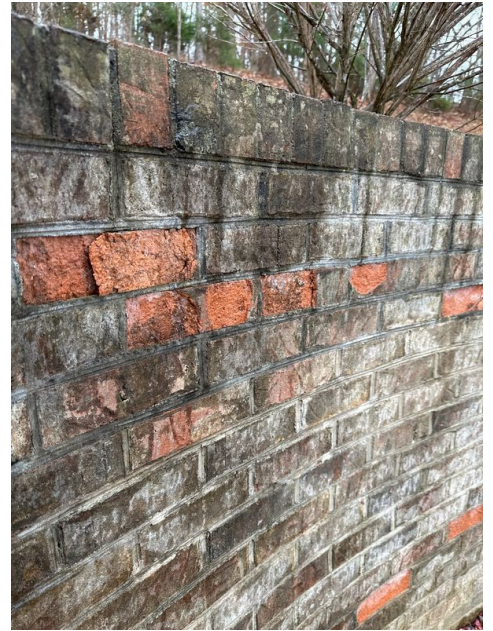
MASONRY - SPALLING

Spalling of the masonry was present on portions of the retaining wall. This is most likely due to moisture/water infiltrating the masonry, and as this moisture freezes in winter months damage to the masonry occurs. Repairs or replacement of any damage is recommended to be performed as needed by a qualified mason.

Contact a qualified masonry professional.

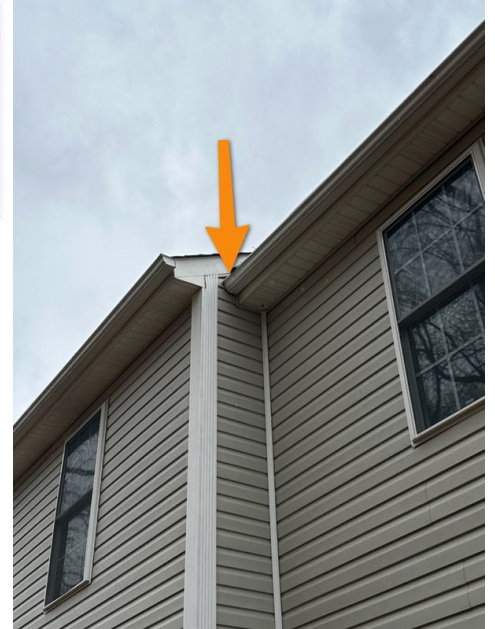
KICKOUT - MISSING

Kickout flashing was not present in area(s) where guttering and/or fascia abutted a sidewall. The installation of kickout flashing is recommended to be performed by a roofing contractor at any areas where gutters or fascia meet a sidewall, preventing rainwater from infiltrating between the end of the gutter/fascia and the wall. Hidden damage may exist in areas where kickout flashing is missing, and this should be investigated during the installation of kickout flashing.

Contact a qualified roofing professional.

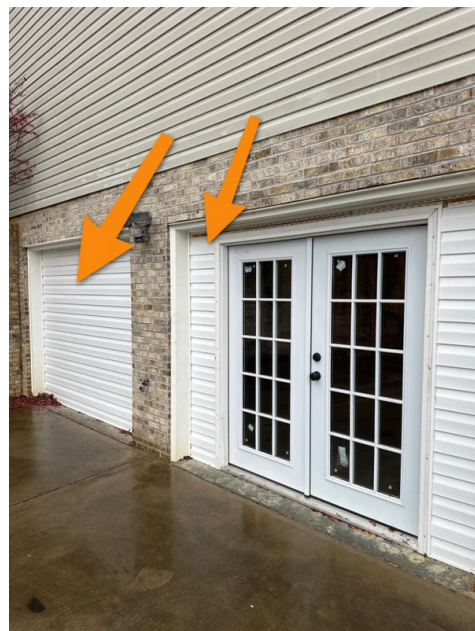
A Water Resistive Barrier (WRB), house wrap, or drainage plane was not present at visible portions under portions of the siding. Siding is not waterproof, and these products help to prevent moisture intrusion and related damage to the sheathing/structure of the home. A proper WRB is recommended to be installed by a qualified contractor for optimal performance/protection of the wall structure.

Contact a qualified professional.

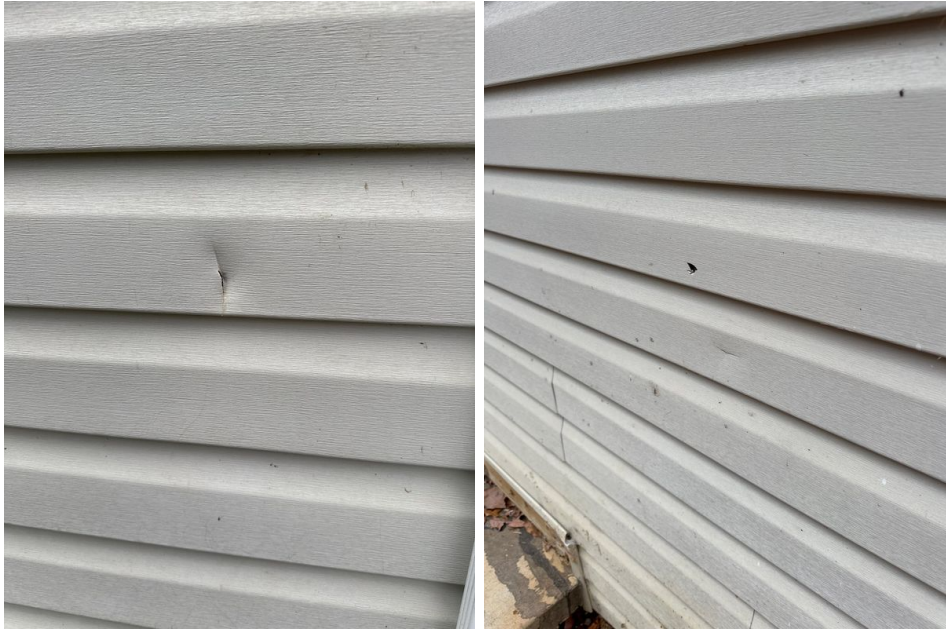
VINYL SIDING - DAMAGE

There was some degree of damage present to areas of the vinyl siding (holes, cracks, etc.). Repairs or replacement of any damaged siding at the home is recommended to be conducted as needed by an exterior contractor or other qualified professional.

Contact a qualified siding specialist.

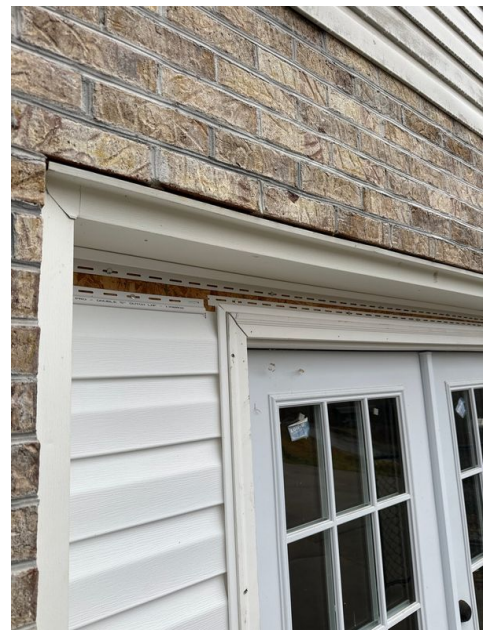
VINYL SIDING - PIECE(S) MISSING

Piece(s) of vinyl siding were missing at the referenced area(s). Replacement of any missing siding is recommended to be performed by a qualified contractor.

Contact a qualified professional.

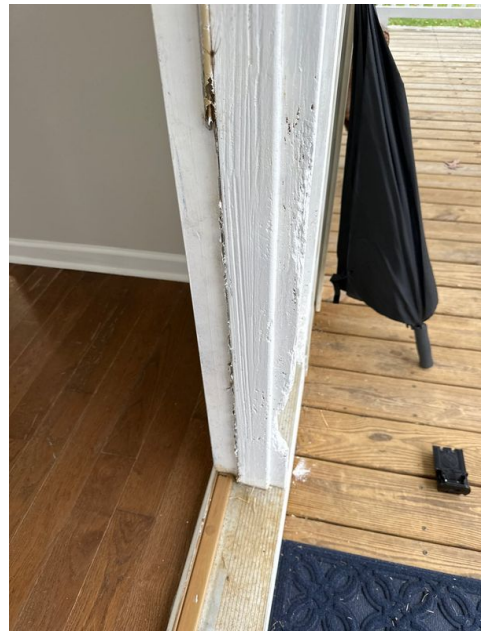
JAMB(S) - DAMAGE (PETS)

There was some degree of damage to the brick moulding, door jambs, interior moulding, and/or weatherstripping presumably from dogs. An evaluation of the damage with repairs made as needed is recommended to be performed by a qualified professional.

Contact a qualified professional.

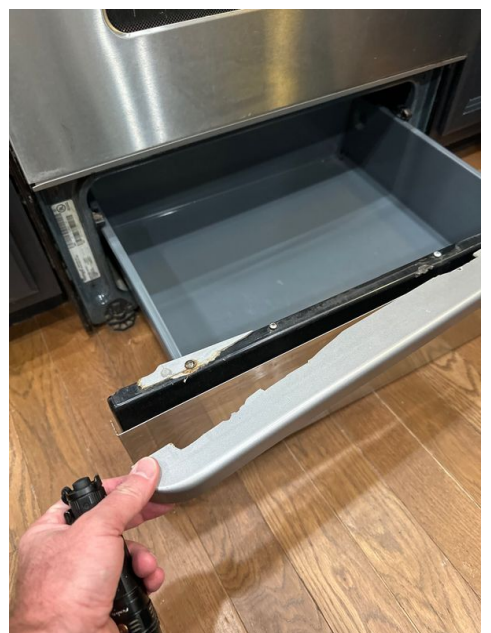
BOTTOM DRAWER - DAMAGED

The range's bottom drawer contained some degree of damage. Repairs or replacement of components made as needed is recommended to be performed by a qualified professional.

Contact a qualified professional.

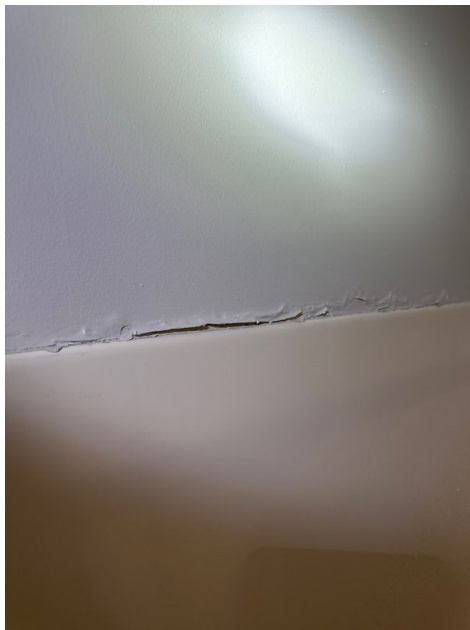
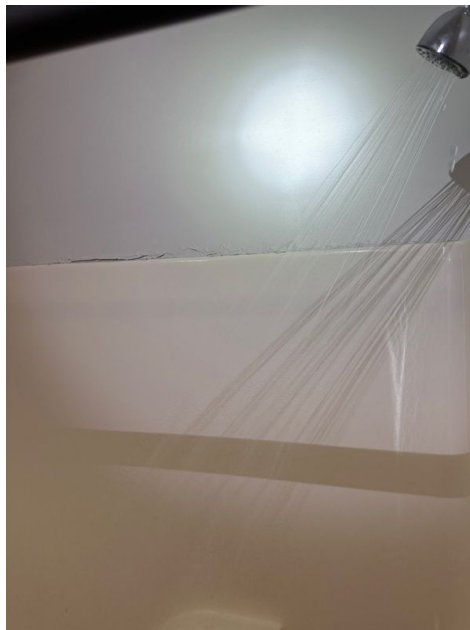
DRYWALL - WATER DAMAGE (ABOVE SHOWER)

Some degree of damage was present to the drywall, where the shower walls meet the drywall in the referenced bathroom(s). Repairs are recommended to be performed to the damage as needed by a drywall contractor or other qualified person.

Contact a qualified drywall contractor.

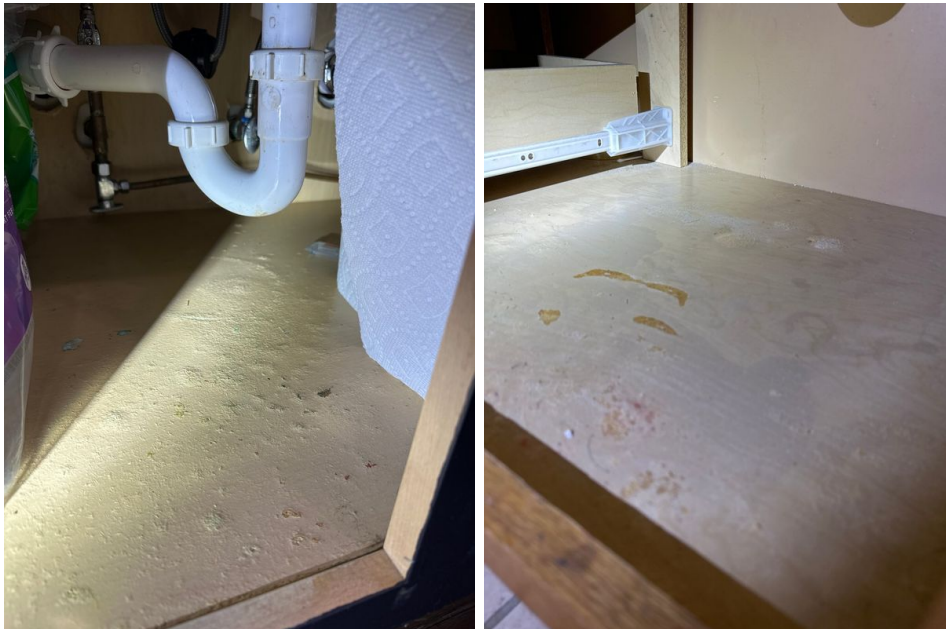
MOISTURE DAMAGE - MINOR TO MODERATE

Minor to moderate moisture damage was present on the cabinet floor below the referenced sink(s). Repairs are recommended to be conducted to any damage present by a qualified person.

Contact a qualified handyman.

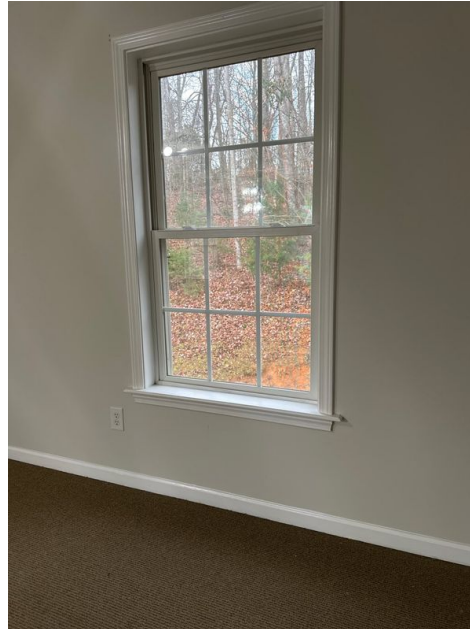
SAFETY - FALL PROTECTION MISSING

SFTY - There were windows present that were within 24 inches of the floor and higher than 72 inches from finished grade outside. Fall protection is recommended to be installed on these windows for child safety by a qualified person. More info can be found at the link below.

Contact a qualified professional.

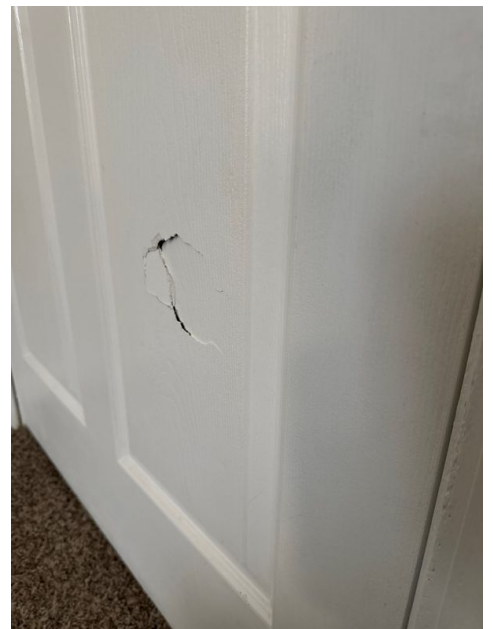
GENERAL - DAMAGED

The referenced door(s) contained some degree of damage. Repairs or replacement of the doors as needed is recommended to be conducted by a qualified person.

Contact a qualified handyman.

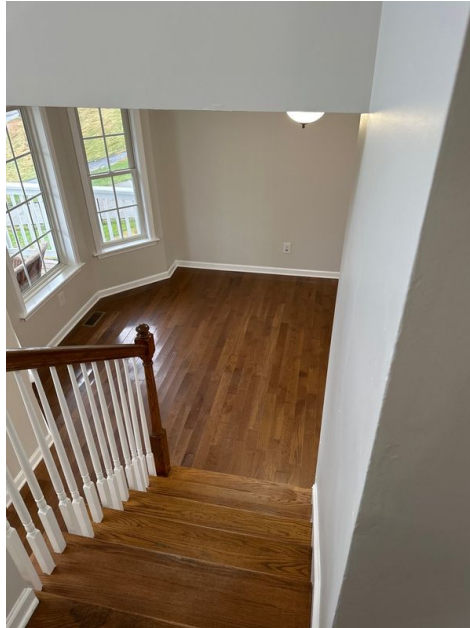
STAIRS - INADEQUATE HEIGHT CLEARANCE

SFTY - The stairway had inadequate height/head clearance in areas. 6'8" of clearance is recommended for safety. I recommend consulting with a qualified contractor regarding any improvements that could be made.

Contact a qualified professional.

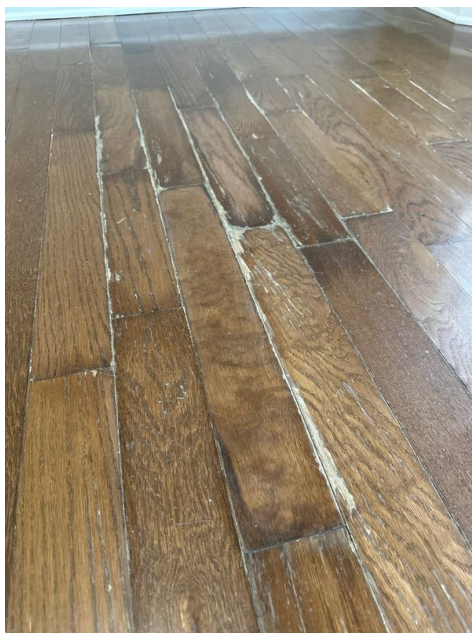
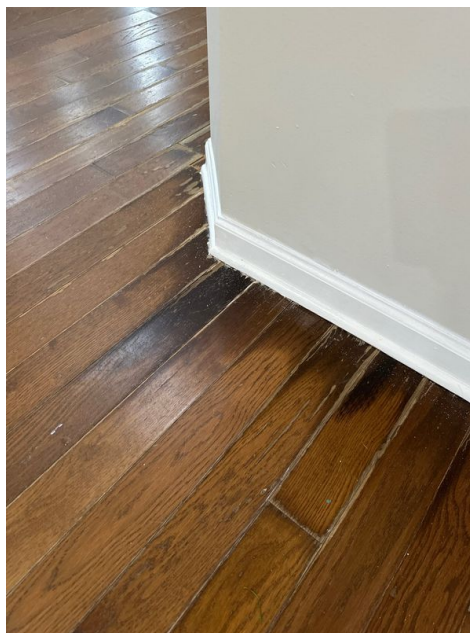
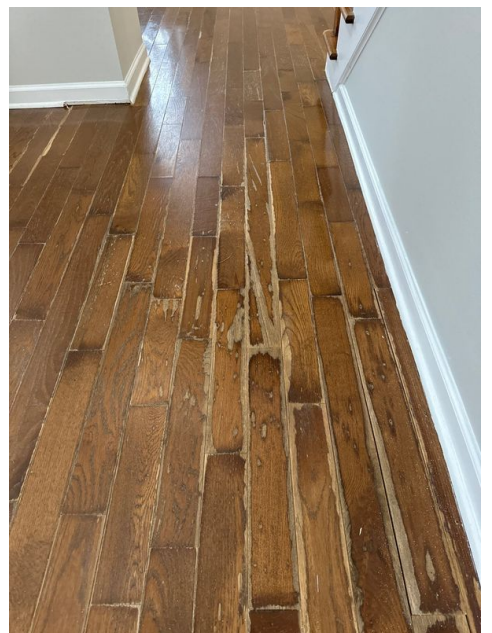
HARDWOOD - DAMAGE

There was some degree of damage present to the hardwood flooring in the referenced area(s). An evaluation of the flooring with repairs made as needed is recommended to be performed by a flooring contractor.

Contact a qualified flooring contractor

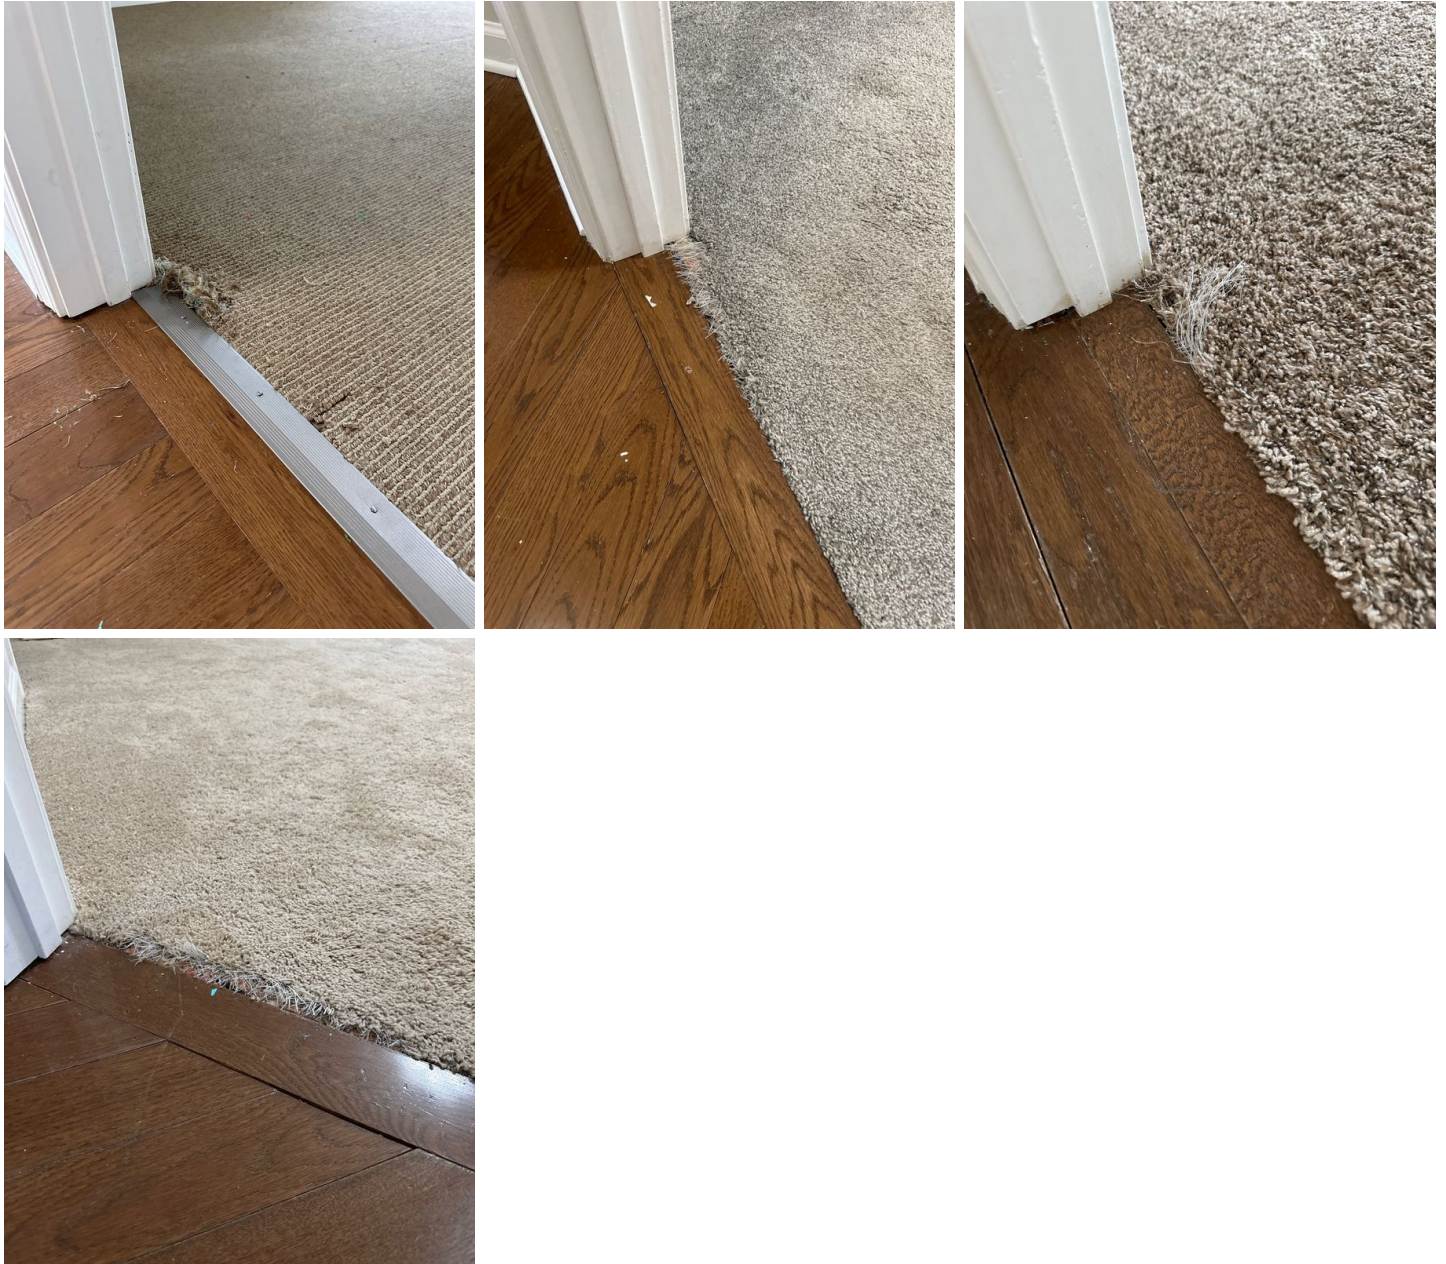
MULTIPLE AREA(S)

CARPET - DAMAGE PRESENT

Damaged carpet was present in the referenced area(s). Replacement of any damaged carpet is recommended to be performed as needed by a flooring contractor.

Contact a qualified flooring contractor

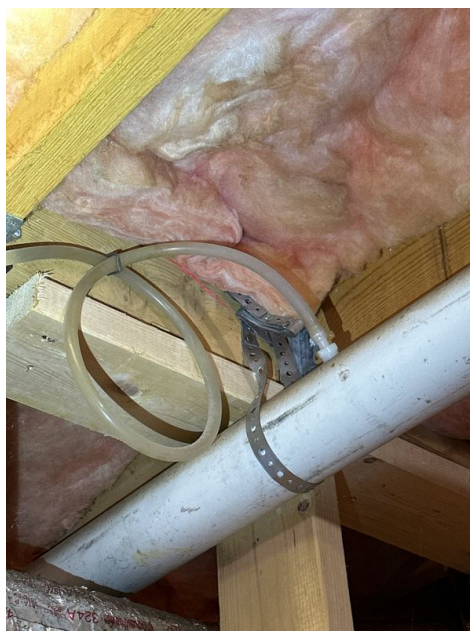
The vinyl condensate drain line from the condensate pump was discharging into a DWV (drain, waste, and vent) pipe. Standards state that condensate can only discharge indirectly to a DWV pipe. An indirect connection would be a connection that is not connected directly with the drainage system, but that discharges into the drainage system through an air break or air gap into a trap, fixture, receptor or interceptor. This connection is also prohibited as DWV pipes can not be drilled or tapped into. Proper routing and termination of the condensate drain pipe is recommended to be conducted by an HVAC contractor, with plugging or repairs made to the DWV pipe made as needed by a licensed plumber.

Contact a qualified HVAC professional.

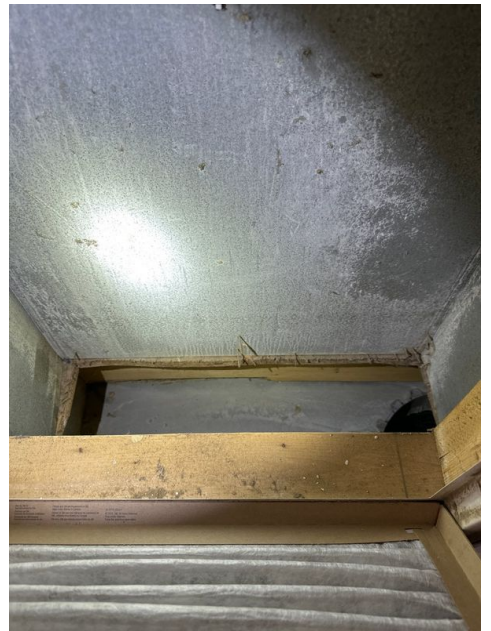
RETURN PLENUM - WALL/FLOOR CAVITY USED (UPGRADE)

The HVAC system used a wall or floor cavity to "return" air to the system. This is not recommended due to being an "unsealed" design, which can allow for dust and/or debris to enter the system. I recommend consulting with an HVAC contractor to discuss upgrade/repair options to include a full sheet metal return.

Contact a qualified heating and cooling contractor

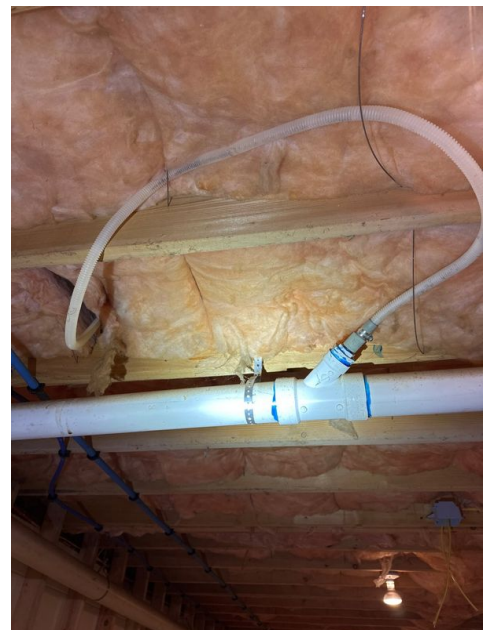
PVC/ABS - IMPROPER HANGERS

There were improper supports and/or hangers used to secure the drain and waste pipes. Improper supports can allow for abrasion of the pipes due to movement and thermal expansion as well as not preventing uplift. Repairs to incorporate proper materials as needed to properly support the pipes is recommended to be conducted by a licensed plumbing contractor.

Contact a qualified plumbing contractor.

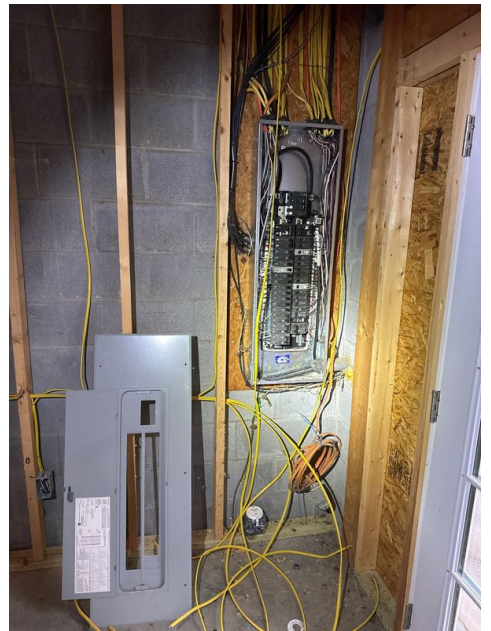
COVER - NOT INSTALLED

Contact a qualified electrical contractor.

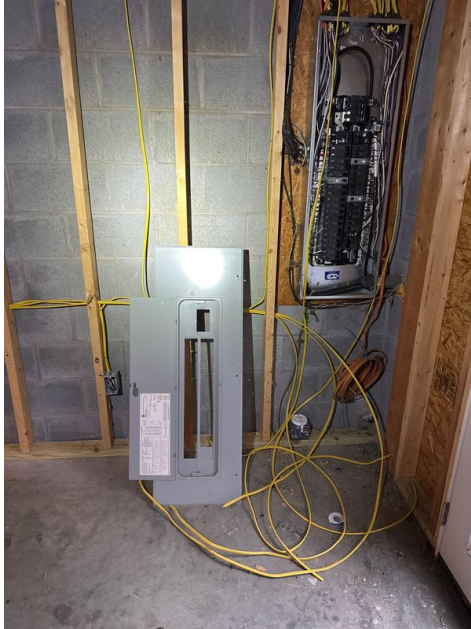
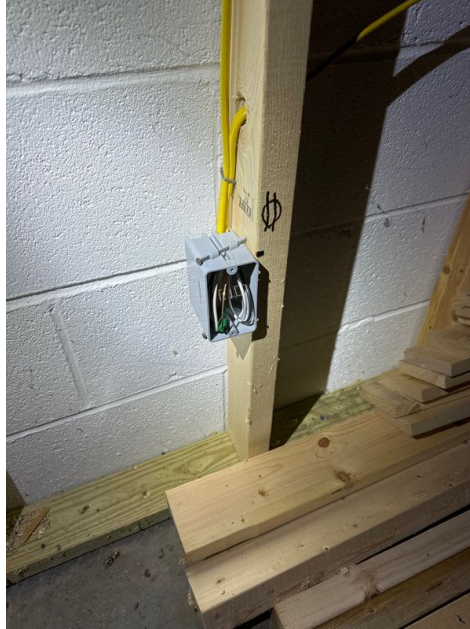
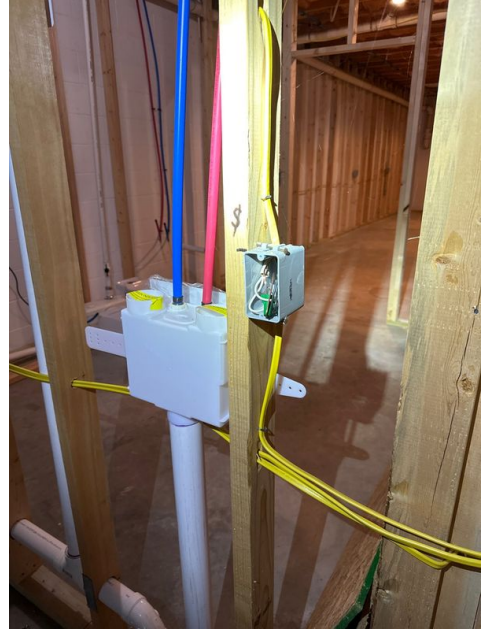
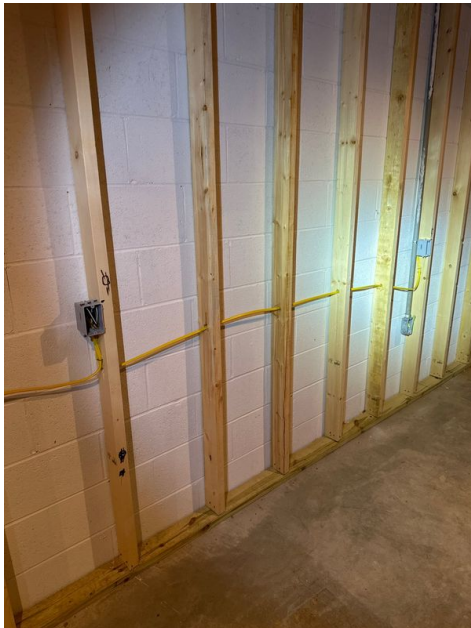
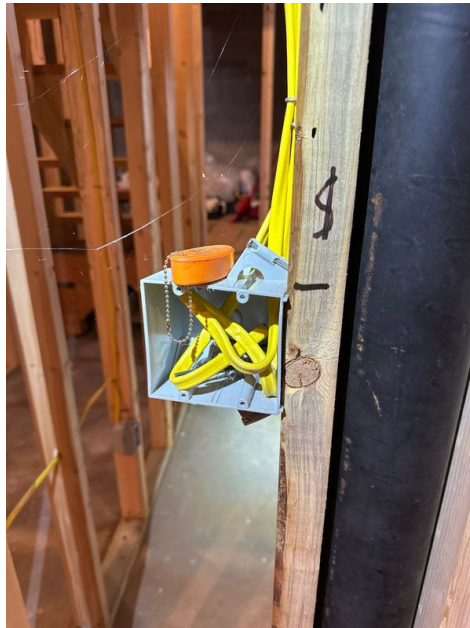
WATER PIPE BONDING - MISSING/NOT VISIBLE

Contact a qualified electrical contractor.

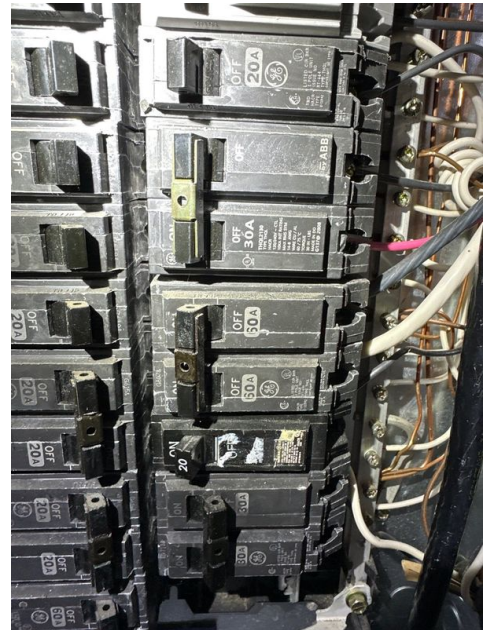
AFCI - UPGRADE RECOMMENDED

Contact a qualified electrical contractor.

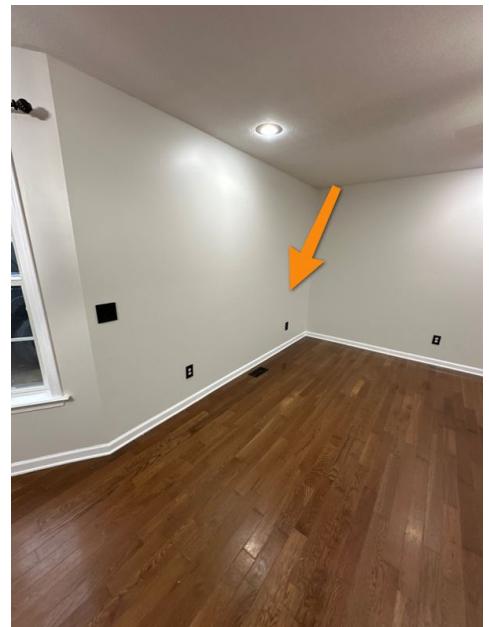
RECEPTACLES - DIFFICULT TO "PLUG INTO"

Contact a qualified electrical contractor.

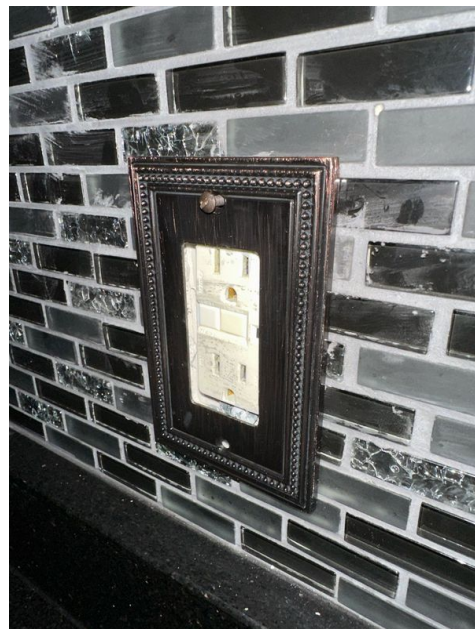
RECEPTACLE(S) - RECESSED INTO WALL

Contact a qualified electrical contractor.

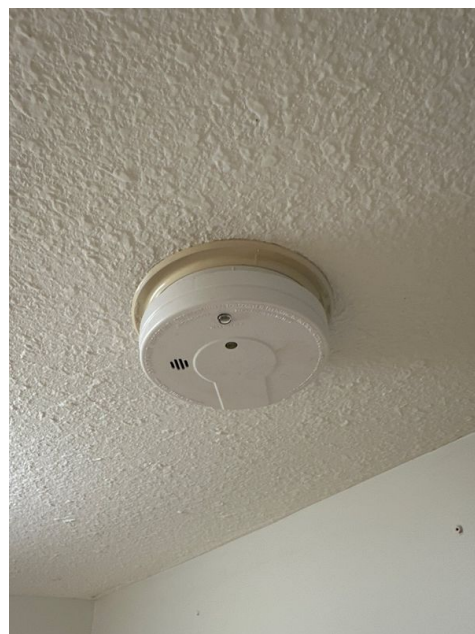
SMOKE DETECTOR(S) - DISCOLORED

Contact a qualified professional.

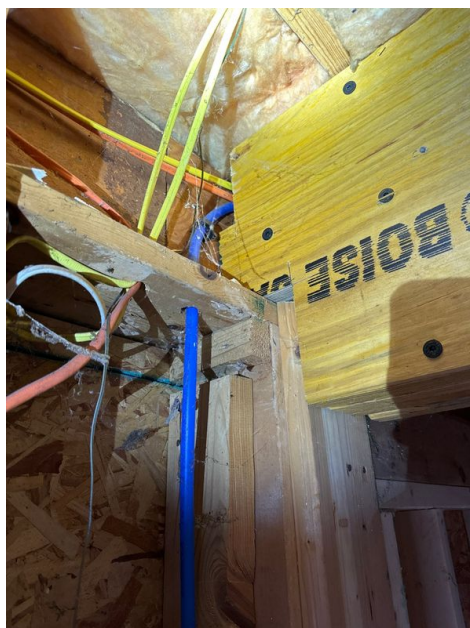
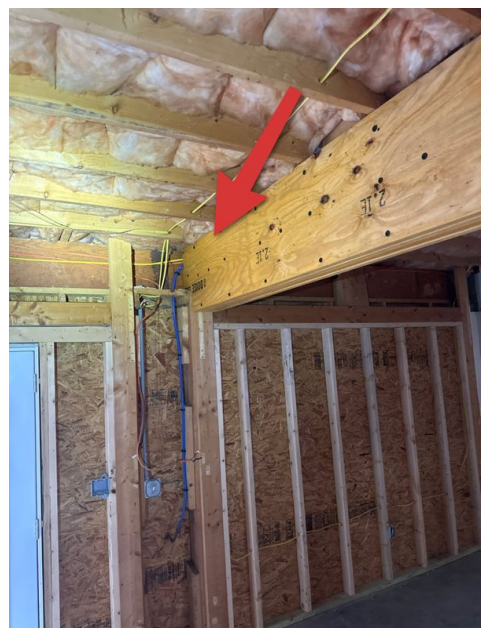
JOISTS - IMPROPER BORING OF HOLES

Contact a qualified professional.

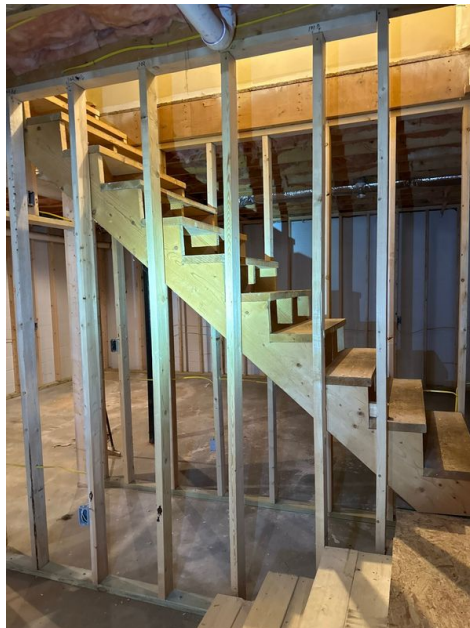
STAIR RAILING - MISSING

Contact a qualified professional.

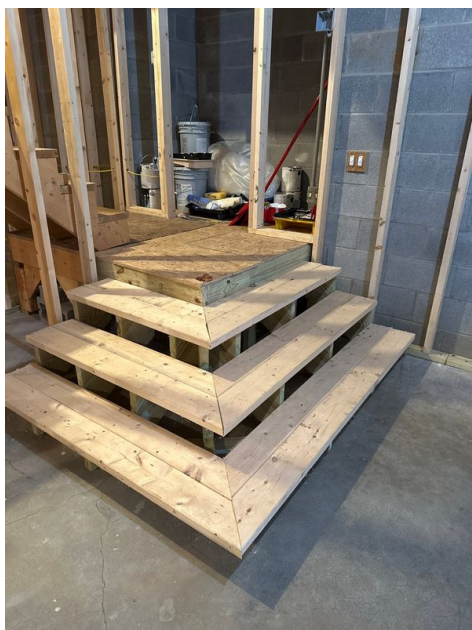
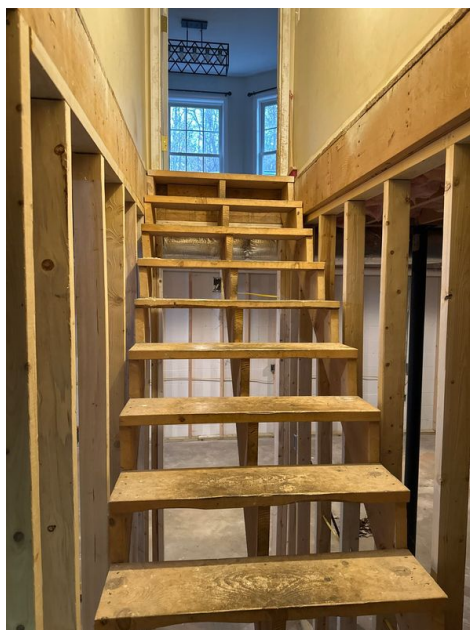
**HANDRAIL - MISSING**

Contact a qualified professional.

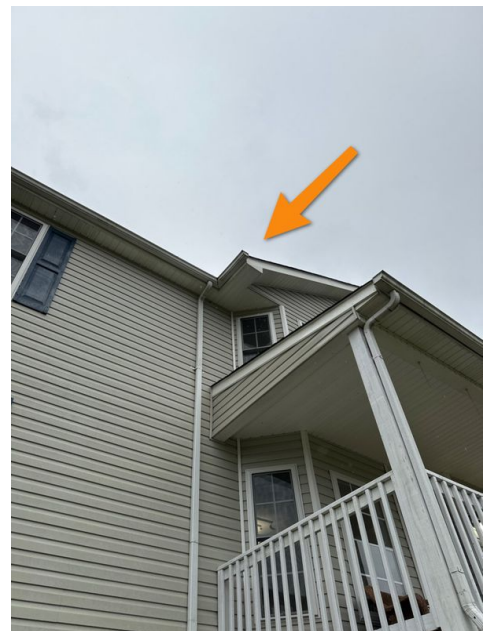
FRONT OF STRUCTURE

GUTTER(S) - LEAKING

Contact a qualified gutter contractor

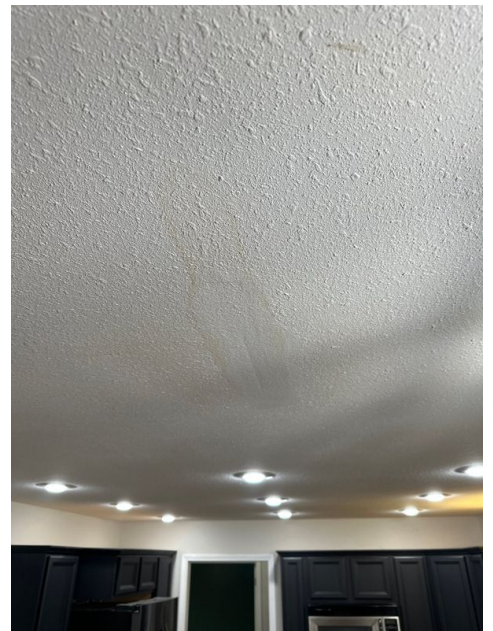
KITCHEN AREA

CEILING - MOISTURE STAINING (PLUMBING)

Contact a qualified plumbing contractor.

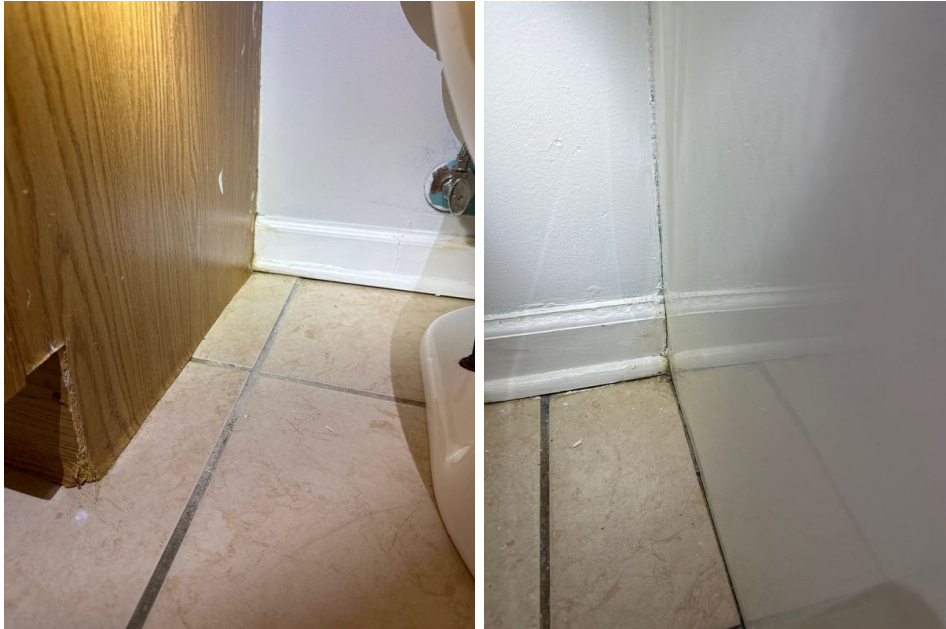
BATHROOM - INDICATIONS OF PAST WATER

Contact the seller for more info

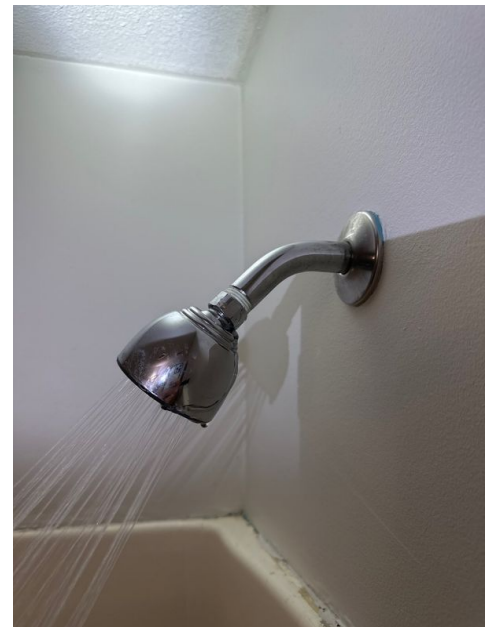
SHOWERHEAD - LEAK FROM CONNECTION

Contact a qualified handyman.
