SUMMARY
1234 Main Street Fall Branch
Tennessee 37656
Buyer Name
12/10/2023 9:00AM

KC Bartley
Certified Master Inspector - TN Lic. #1244
Professional Home Inspections LLC
(423) 306-0508
kc@prohitn.com

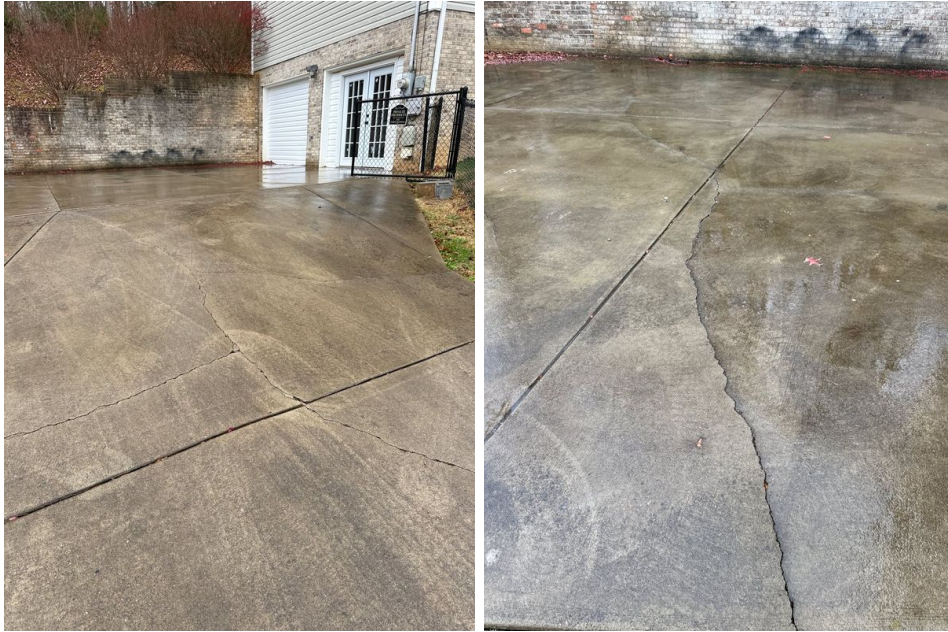
DRIVEWAY @ LEFT SIDE OF STRUCTURE

CRACKING - MODERATE

Contact a qualified concrete contractor.

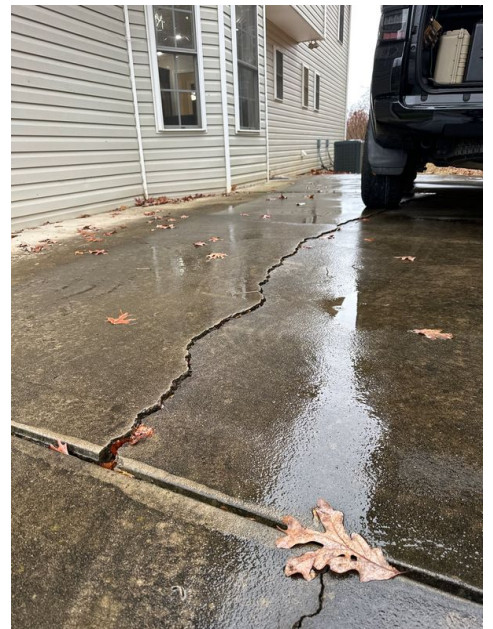
DRIVEWAY @ REAR OF STRUCTURE

**CRACKING - SIGNIFICANT**

Contact a qualified concrete contractor.

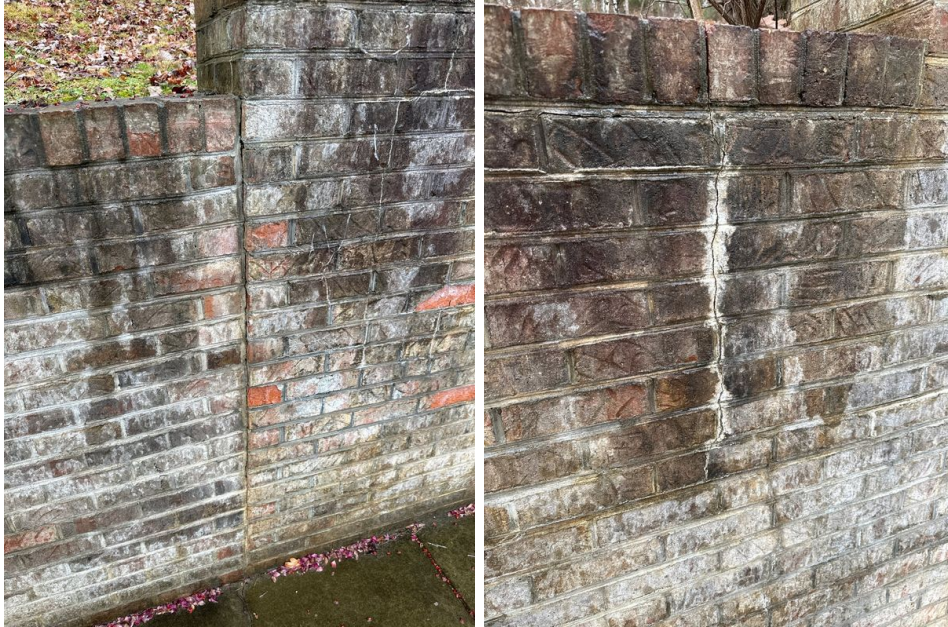
CRACKING - MINOR

Contact a qualified professional.
