SUMMARY
1234 Main Street Fall Branch
Tennessee 37656
Buyer Name
12/10/2023 9:00AM

KC Bartley
Certified Master Inspector - TN Lic. #1244
Professional Home Inspections LLC
(423) 306-0508
kc@prohitn.com

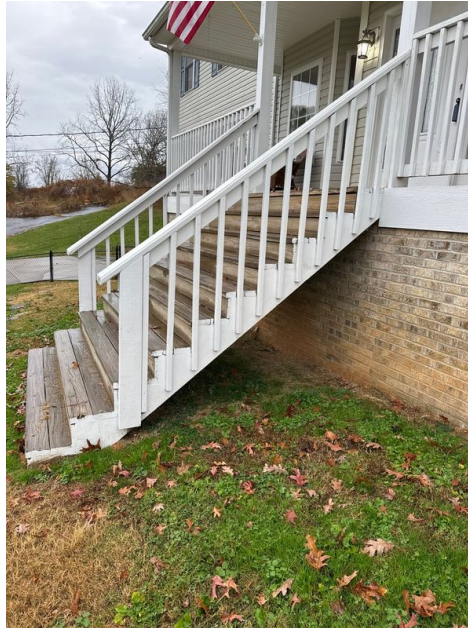
STRINGER(S) - MISSING HANGERS

Hangers were not used to secure the stringers to the deck framing. The installation of slopeable hangers is recommended to be performed by a qualified person to properly secure the stringers.

Contact a qualified deck contractor.

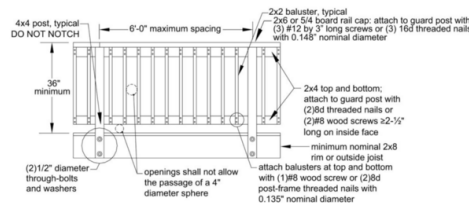
BALUSTER(S) - IMPROPER ATTACHMENT

There were balusters present that were not properly attached/secured. Safety standards require for balusters to be attached at the top and bottom with either (1) #8 wood screw, or (2) 8d nails. Repairs to properly secure the balusters is recommended to be conducted by a qualified contractor.

Contact a qualified professional.

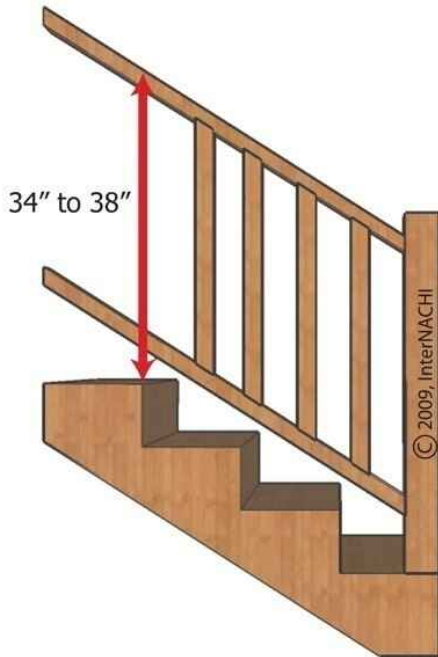
STAIR RAILING - HEIGHT LESS THAN 34"

SFTY - The stair railing height was less than 34". Current safety standards require the height of stair railing to be between 34" - 38" for safety. Safety upgrades or modifications are recommended to be conducted here by a qualified contractor.

Contact a qualified professional.

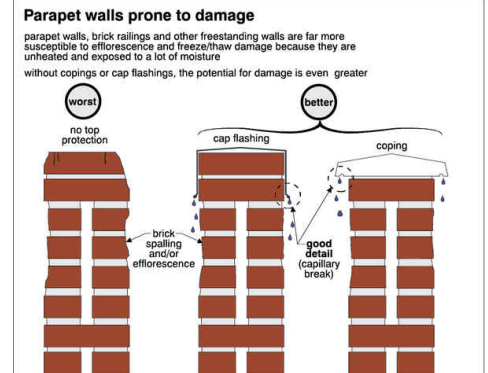
MASONRY - SPALLING

Spalling of the masonry was present on portions of the retaining wall. This is most likely due to moisture/water infiltrating the masonry, and as this moisture freezes in winter months damage to the masonry occurs. Repairs or replacement of any damage is recommended to be performed as needed by a qualified mason.

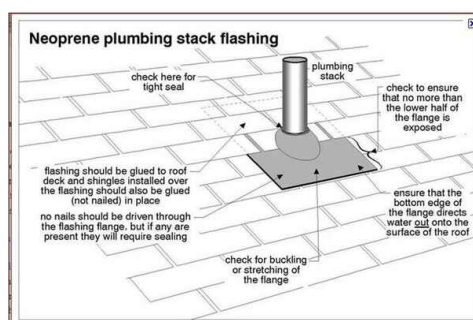
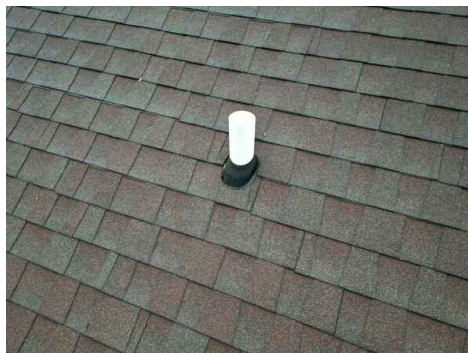
There were flashing rain boot(s) present that were completely covered by shingles. In a proper installation, the upper portion of the rain boot would be covered by shingles, while the lower third would be exposed on top of the shingles to adequately shed rainwater. Repairs are recommended to be conducted as needed by a roofing contractor.

Contact a qualified roofing professional.

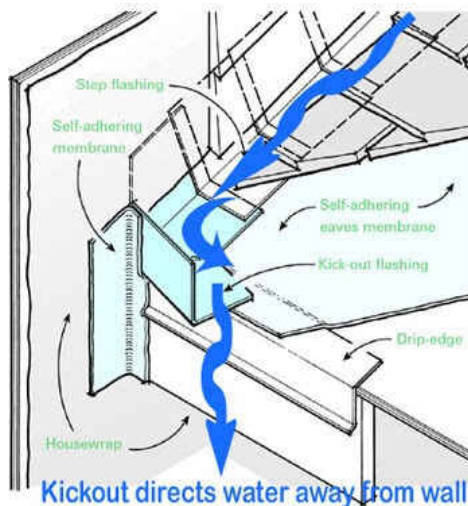
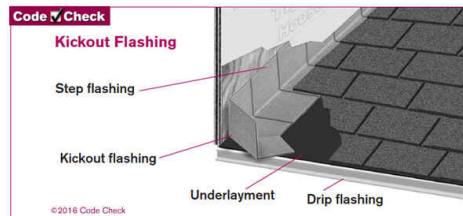
KICKOUT - MISSING

Kickout flashing was not present in area(s) where guttering and/or fascia abutted a sidewall. The installation of kickout flashing is recommended to be performed by a roofing contractor at any areas where gutters or fascia meet a sidewall, preventing rainwater from infiltrating between the end of the gutter/fascia and the wall. Hidden damage may exist in areas where kickout flashing is missing, and this should be investigated during the installation of kickout flashing.

Contact a qualified roofing professional.

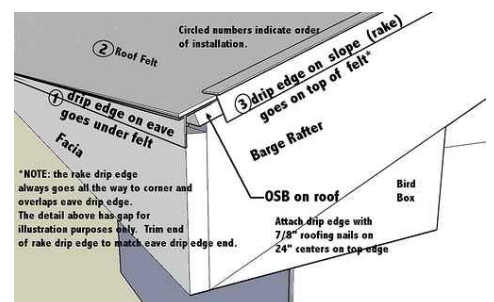
RAKE EDGE - NOT PRESENT

Rake edge flashing was not present below the shingles at the home's referenced area(s). Rake edge flashing prevents water infiltration and damage to the sheathing below the shingles and fascia board. The installation of rake edge flashing is recommended to be performed either now or at the next roof replacement as deemed necessary by a roofing contractor.

Contact a qualified roofing professional.

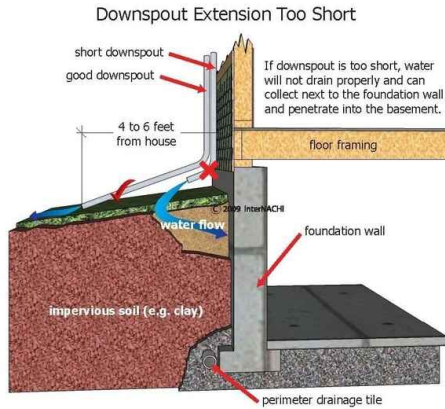
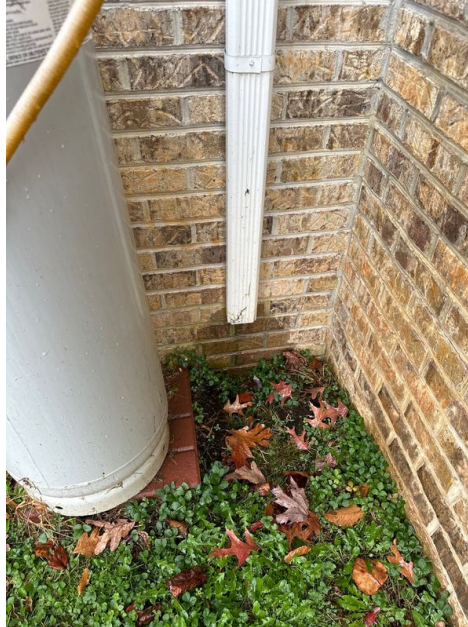
DOWNSPOUT(S) - TERMINATING NEAR FOUNDATION

There were downspouts present that were discharging within five feet of the foundation of the home. Current standards require downspouts to be diverted at least five feet from the foundation of the home to prevent the grounds surrounding the foundation from becoming saturated. Saturated grounds can allow water/moisture to enter basement and crawl space areas, and in extreme cases, can allow for settlement of the home. Properly extending all downspouts at least five feet away from the home is recommended to be conducted by a gutter contractor or other qualified person.

Contact a qualified gutter contractor

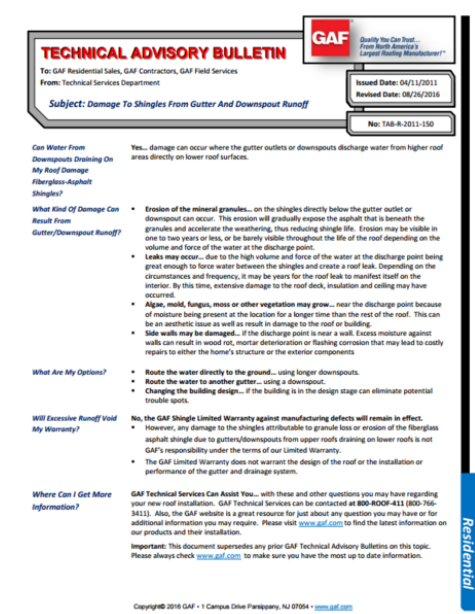
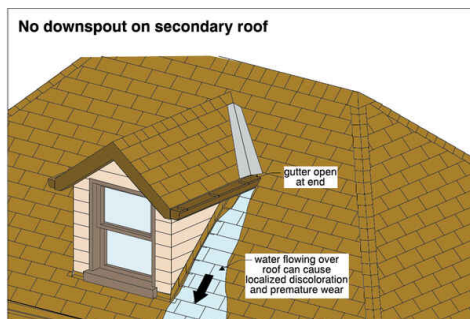
DOWNSPOUT(S) - TERMINATING ON ROOF SURFACE

There were gutters and/or downspouts present that were discharging onto the roof surface. Shingle manufacturers will not cover damage to the shingles caused by guttering discharging water onto the roof surface. This discharged water can loosen the ceramic granules and cause premature aging of the shingle surface. (attached is a technical bulletin from GAF addressing this) The downspouts are recommended to be routed to discharge into the lower guttering by a gutter contractor.

Contact a qualified gutter contractor

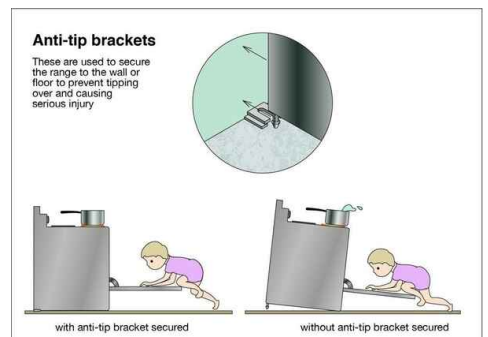
SAFETY - ANTI-TIP BRACKET MISSING

SFTY - An anti-tip bracket was not installed for the range (and, if present, did not prevent the range from tipping). An anti-tip bracket prevents the range from tipping over if weight is applied to an open oven door, such as a child stepping or sitting on the door. Ranges contain a warning label inside the oven door with more information. This bracket can be purchased at home improvement stores for approximately ten dollars. The installation of an anti-tip bracket is recommended to be conducted by a qualified person for safety.

Contact a qualified professional.

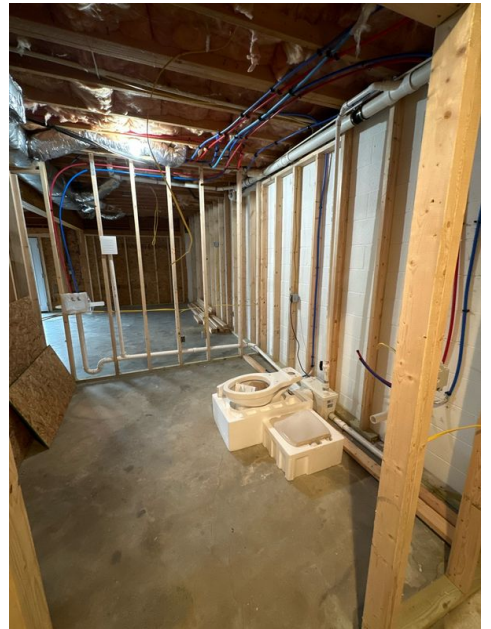
DWV PIPE(S) - TAPPED AND/OR DRILLED

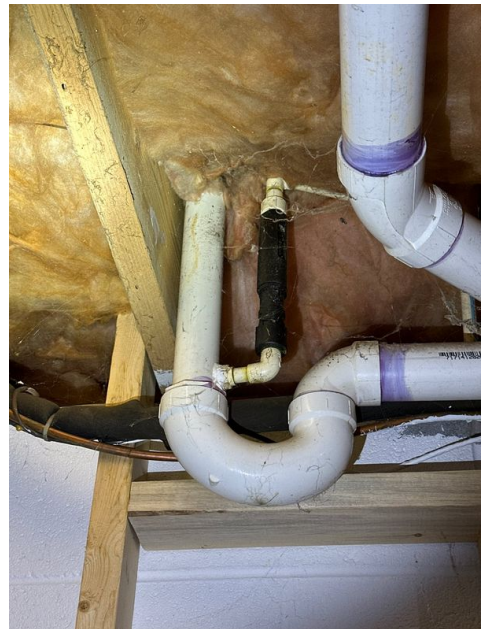
PVC/ABS - IMPROPER HANGERS

There were improper supports and/or hangers used to secure the drain and waste pipes. Improper supports can allow for abrasion of the pipes due to movement and thermal expansion as well as not preventing uplift. Repairs to incorporate proper materials as needed to properly support the pipes is recommended to be conducted by a licensed plumbing contractor.

Contact a qualified plumbing contractor.

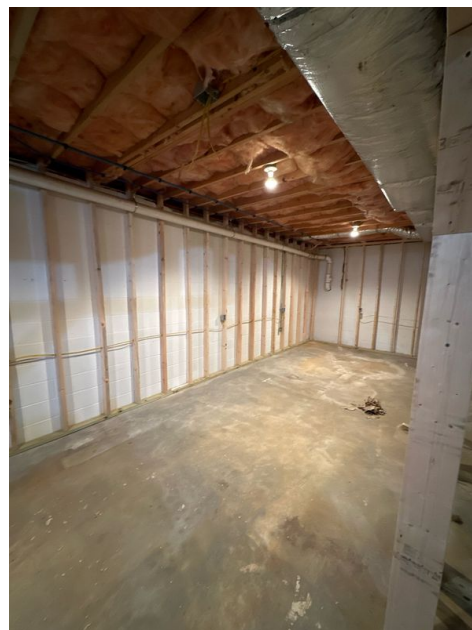
JOISTS - IMPROPER BORING OF HOLES

Contact a qualified general contractor.

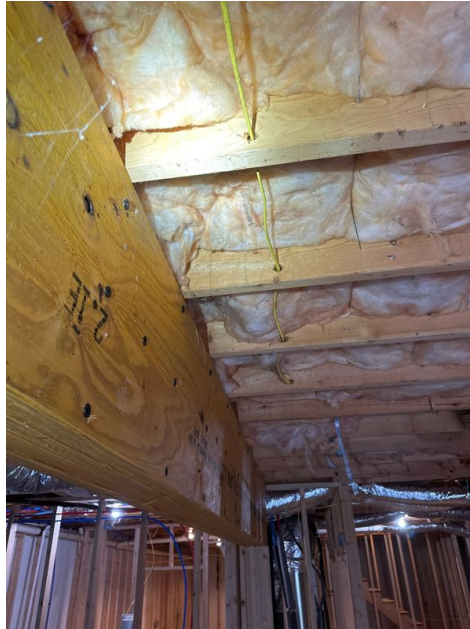
**BEAM/GIRDER - LVL ALTERED**

Contact a qualified professional.

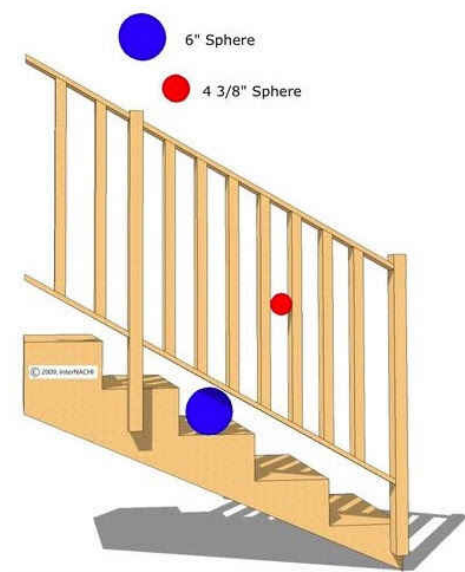
STAIRS - OPEN RISERS

Contact a qualified professional.

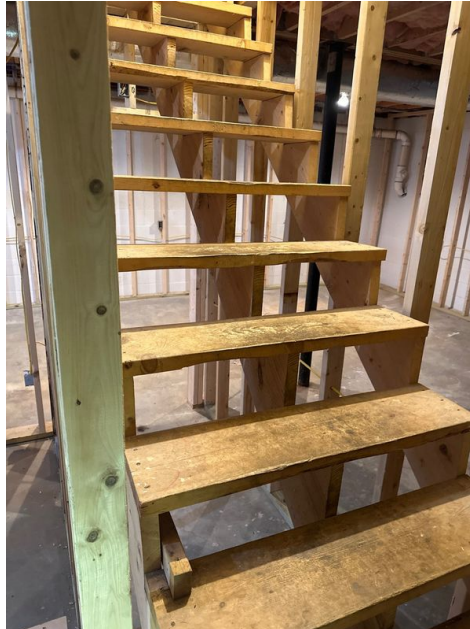
**HANDRAIL - MISSING**
